# S I T E P H O T O S

A1	SITE PHOTOS VICINITY MAP TABLE OF CONTENTS
A2	ROOF PLAN
A3	REFLECTED CEILING PLAN
A4	SECTION,
A5	WINDOW AND DOOR SCHEDULE
S1	ROOF FRAMING PLAN
S2	RAFTER DETAIL
E1	ELECTRICAL LIGHTING LAYOUT

<b>HAZELINE N. TIBANGAY</b> UNIVERSITY ARCHITECT	PRC LIC. No. 028540 PTR No.	VALIDITY: ISSUED:	PRC LIC. No. PTR No.	VALIDITY: ISSUED:	PROJECT / LOCATION REPAIR OF THE ELS - HOME ECONOMICS and HEALTH & SCIENCE BUILDING BSU, KM 6.5 BSU COMPOUND LA TRINIDAD, BENGUET

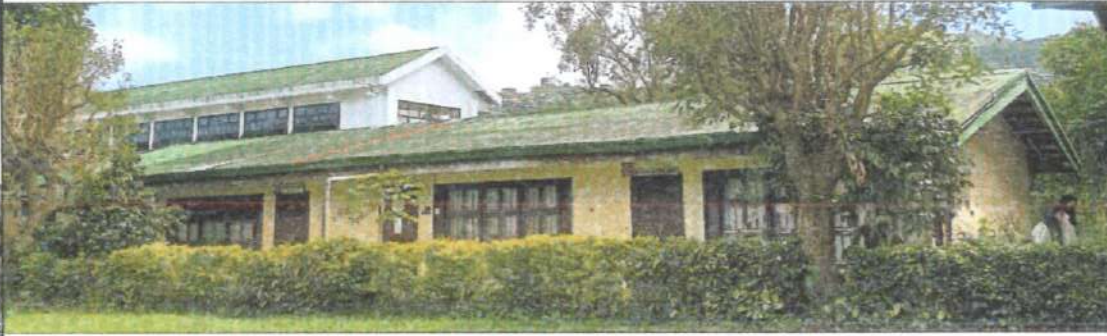
Existing corrugated roofing sheets to be removed and replaced

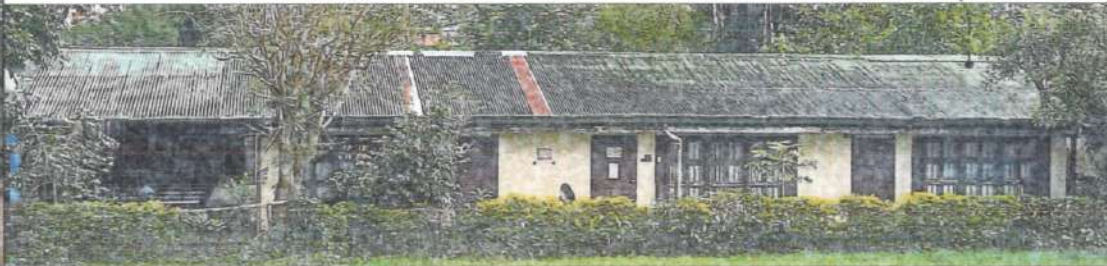
Existing wood awning window to be removed and replaced with pre-fabricated steel awning window with grills  
Existing wood panel door to be removed and replaced with pre-fabricated steel door  
Center door to be removed and to be covered with chb ; plaster and paint finished

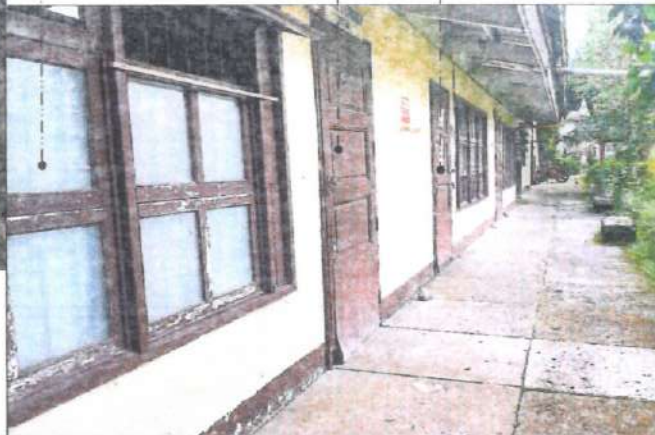
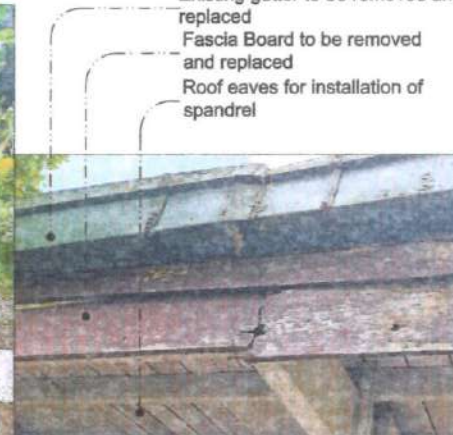
Existing gutter to be removed and replaced  
Fascia Board to be removed and replaced  
Roof eaves for installation of spandrel

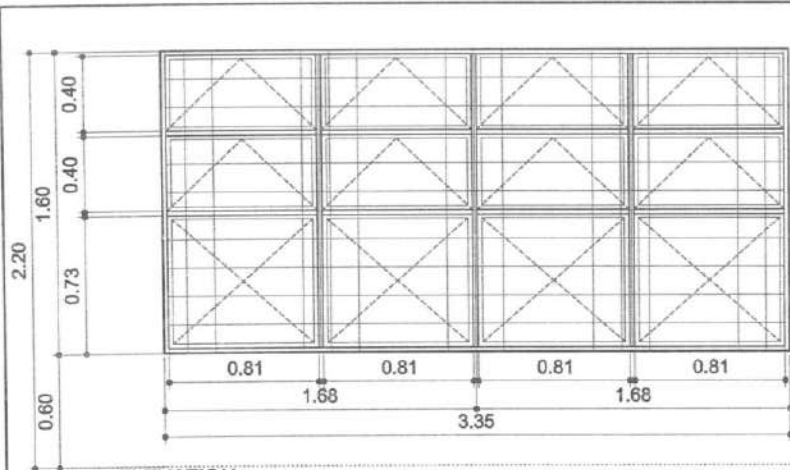
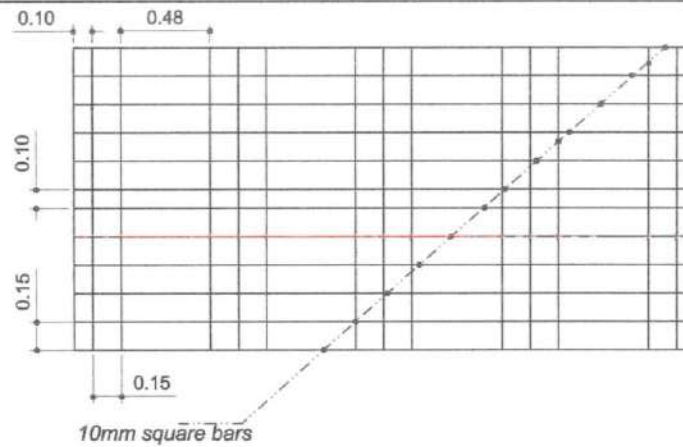
1 DOORS AND WINDOWS  
A5 SCALE 1 : 40 MTS

ELEVATION

10mm square bars

PLAN

GRILLS DESIGN

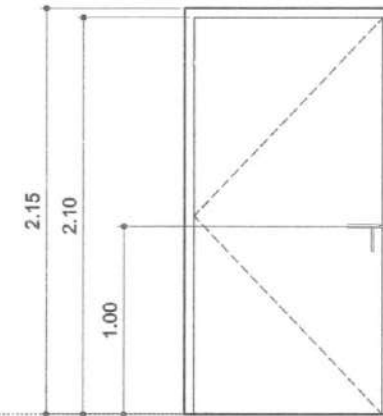
\*\*\*Pre-fabricated steel door with jamb; complete accessories and hardware

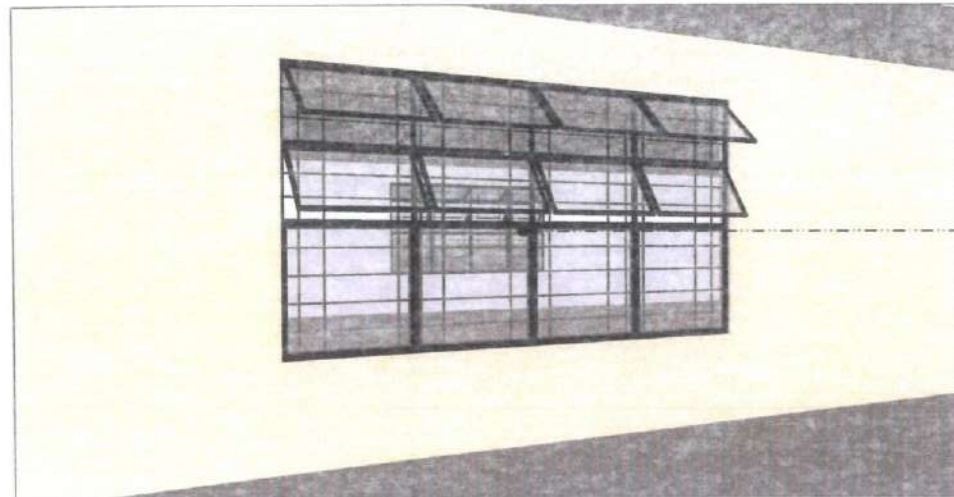
PRE-FABRICATED STEEL AWNING WINDOW WITH GRILLS

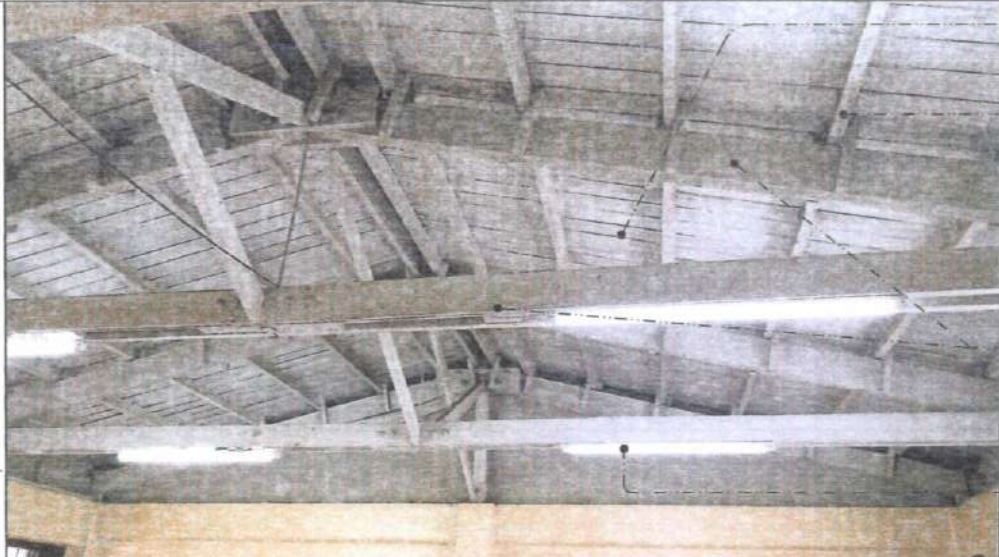
Existing wood plank to be removed and replaced

Existing purlins to be removed and replaced

Existing structural frames to be retained

Existing lighting fixture to be replaced with 2-T8 with housing and diffuser
